**Flood Control Project Maintenance
Levee Inspections**
LMA District Cover Sheet
Spring 2017 Levee Inspection Results

Reclamation District No. 2104 Peters Pocket Tract

Levee Inspection Report By Mile - Spring 2017

Waterway	Bank	Unit Miles	Inspection Start/End	Inspector
Unit No. 01 Cache Slough/Unit No. 02 Haas Slough	Left	6.85	04/12/2017 04/12/2017	Herman Phillips

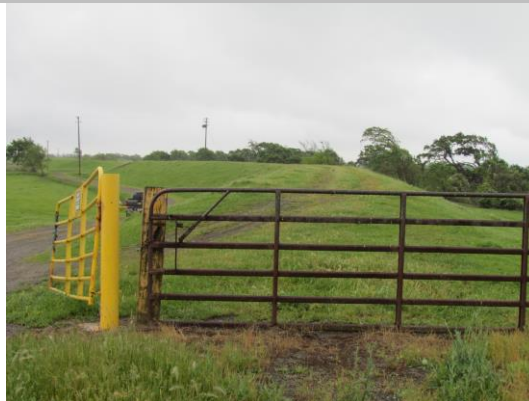
Photo 1 of 1 : SP_2017_RD2104_249_11_20170523_00042.jpg

LM Start	0.01	Rating **	M	Issue No.	11	
LM End	0.88	Issue Type +	Ma	Location *	LS	
Category	Earthen Levee			GPS Latitude/Longitude		
				Start		End
Item	Vegetation			38.308100 °		38.299327 °
				-121.758573 °		-121.749800 °
DWR ID	DWR_RD2104_01_s_2017_11					
Comment Code						
V1 : Control annual grass and weeds on the levee slopes and easements.						
Inspector Comment

RD 2104 Looking downstream from 0.00 -0.88.

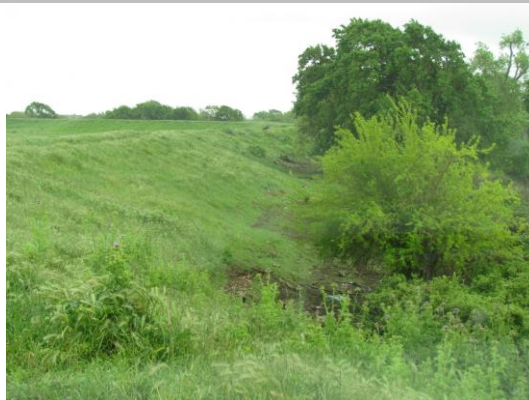
Photo 1 of 1 : SP_2017_RD2104_249_17_20170518_00039.jpg

LM Start	0.01	Rating **	U	Issue No.	17
LM End	5.72	Issue Type +	Ma	Location *	WS
Category	Earthen Levee			GPS Latitude/Longitude	
				Start	End
Item	Vegetation			38.308090 °	38.324538 °
				-121.758615 °	-121.758098 °
DWR ID	DWR_RD2104_01_f_2016_17				
Comment Code					
V1 : Control annual grass and weeds on the levee slopes and easements.					
Inspector Comment					
Control annual grasses and weeds on the waterside slope.

RD 2104 Waterside levee slope levee mile 0.01-1.43.

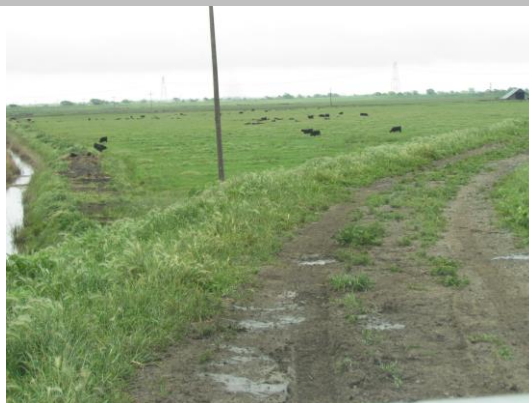
Photo 1 of 1 : SP_2017_RD2104_249_26_20170523_00043.jpg

LM Start	0.88	Rating **	U	Issue No.	26
LM End	5.72	Issue Type +	Ma	Location *	LS
Category	Earthen Levee			GPS Latitude/Longitude	
				Start	End
Item	Vegetation			38.299327 °	38.324538 °
				-121.749802 °	-121.758098 °
DWR ID	DWR_RD2104_01_s_2017_26				
Comment Code					
V1 : Control annual grass and weeds on the levee slopes and easements.					
Inspector Comment					
No maintenance has been done to the levee section from levee mile 0.88-5.72.

RD 2104 Looking downstream from levee mile 0.88- 5.72.

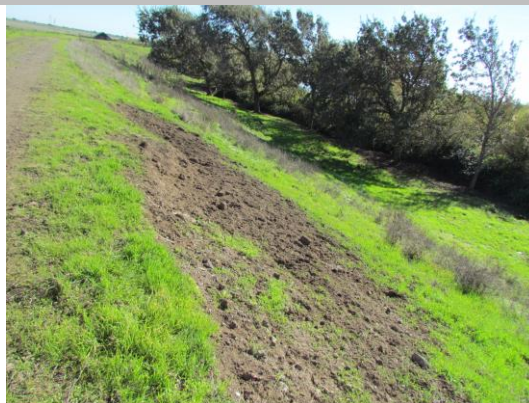
Photo 1 of 1 : SP_2017_RD2104_249_22_20170404_00002.jpg

LM Start	1.20	Rating **	U	Issue No.	22
LM End	1.20	Issue Type +	Ma	Location *	WS
Category	Earthen Levee			GPS Latitude/Longitude	
				Start	End
Item	Erosion / Bank Caving			38.296615 °	38.296615 °
				-121.745372 °	-121.745372 °
DWR ID	DWR_RD2104_01_f_2016_22				
Comment Code					
E2 : Schedule repair of erosion site prior to the next inspection.					
Inspector Comment					
Make the repairs to the erosion site listed on the waterside slope.

RD 2104 Levee mile 1.20 waterside slope.

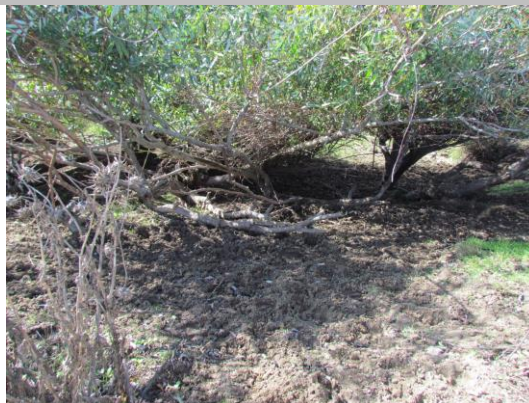
Photo 1 of 1 : SP_2017_RD2104_249_23_20170404_00003.jpg

LM Start	1.27	Rating **	M	Issue No.	23
LM End	1.27	Issue Type +	Ma	Location *	WS
Category	Earthen Levee			GPS Latitude/Longitude	
				Start	End
Item	Slope Stability			38.296182 °	38.296182 °
				-121.744318 °	-121.744318 °
DWR ID	DWR_RD2104_01_f_2016_23				
Comment Code					
S1 : Repair slope instability.					
Inspector Comment					
Repair the slope damaged by cows and trim up the tree limbs partially blocking the erosion site.

RD 2104 Levee mile 1.27 wateside.

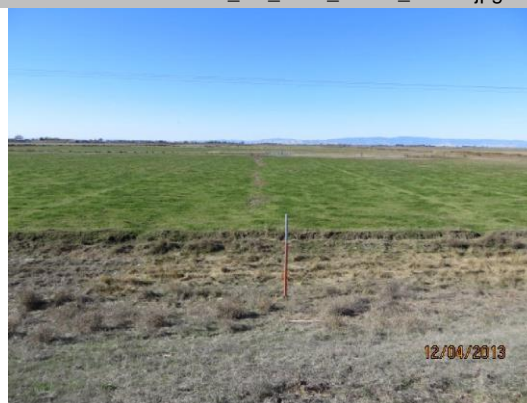
Photo 2 of 3 : UCIP_SP_2017_41834_45068.jpg

LM Start	3.04	Rating **	M	Issue No.	122 (cont)
LM End	3.04	Issue Type +	En	Location *	WS
Category	Supplemental			GPS Latitude/Longitude	
				Start	End
Item	DWR UCIP Field Study			38.299447 °	38.299447 °
				-121.730444 °	-121.730444 °
DWR ID					
Comment Code					
Inspector Comment					
FS_ID:41834 DS_ID:24720 EP_NO: 14184 Repair Type: Non-Urgent Crossing Status: Found UCIP Comments: Signs in disrepair and need proper markings. FIELD_STRUCT_DESC: 6-inch steel gasoline through the levee 3-feet below the crown. Signs on LS and WS toe. FS Date: 12/4/2013

Sign post on LS toe.

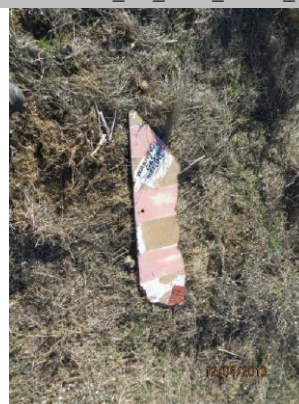
Photo 3 of 3 : UCIP_SP_2017_41834_45070.jpg

Broken sign marker on LS toe.

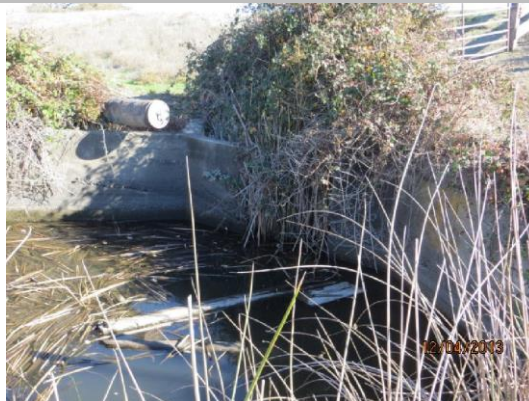
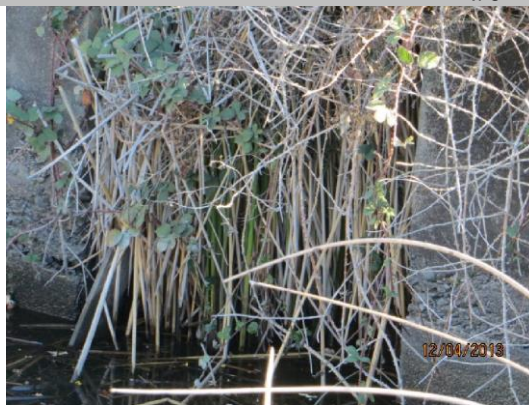
LM Start	3.12	Rating **	M	Issue No.	123
LM End	3.12	Issue Type +	En	Location *	CR
Category	Supplemental			GPS Latitude/Longitude	
				Start	End
Item	DWR UCIP Field Study			38.300605 °	38.300605 °
				-121.730440 °	-121.730440 °
DWR ID					
Comment Code					
Inspector Comment					
FS_ID:24992 DS_ID:24707 EP_NO: 4412 Repair Type: Non-Urgent Crossing Status: Indicator Found UCIP Comments: Heavy vegetation at concrete headwall on LS toe and at possible outlet area on WS toe. If possible, vegetation should be cleared to check if this is an accurate location. Erosion around backside of headwall at LS toe. FIELD_STRUCT_DESC: 4 x 4 concrete culvert through the levee 17.0-feet below the crown. Originally included in O+M manual, 1964. Concrete headwall on LS toe. FS Date: 12/4/2013

Vegetation covering possible location for 4X4 concrete culvert at LS toe.

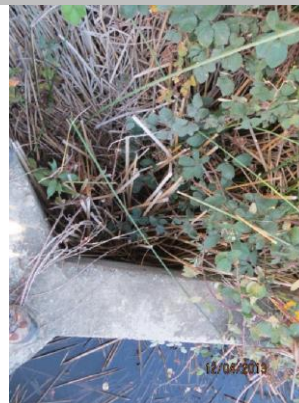
Photo 3 of 3 : UCIP_SP_2017_24992_45049.jpg

LM Start	3.12	Rating **	M	Issue No.	123 (cont)
LM End	3.12	Issue Type +	En	Location *	CR
Category	Supplemental			GPS Latitude/Longitude	
				Start	End
Item	DWR UCIP Field Study			38.300605 °	38.300605 °
				-121.730440 °	-121.730440 °
DWR ID					
Comment Code					
Inspector Comment					
FS_ID:24992 DS_ID:24707 EP_NO: 4412 Repair Type: Non-Urgent Crossing Status: Indicator Found UCIP Comments: Heavy vegetation at concrete headwall on LS toe and at possible outlet area on WS toe. If possible, vegetation should be cleared to check if this is an accurate location. Erosion around backside of headwall at LS toe. FIELD_STRUCT_DESC: 4 x 4 concrete culvert through the levee 17.0-feet below the crown. Originally included in O+M manual, 1964. Concrete headwall on LS toe. FS Date: 12/4/2013

Some erosion on levee side of headwall at LS toe.

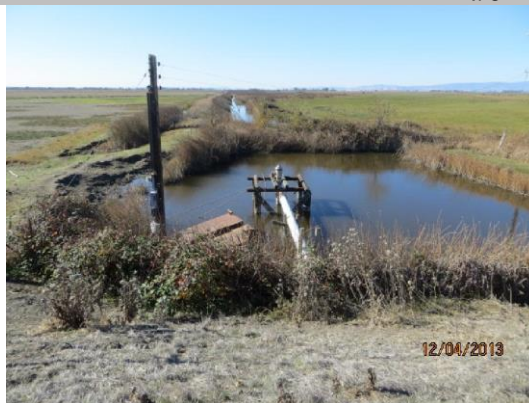
Photo 1 of 3 : UCIP_SP_2017_51640_45056.jpg

FS_ID:51640
DS_ID:24706
EP_NO: 10183
Repair Type: Urgent
Crossing Status: Found
UCIP Comments: 12/06/2016 Pipe has been replaced with PVC pipe. The crossing is non-functional due to pipe not attached to new pump. Need to contact owner. Owner will need to coordinate with CVFPB regarding the modifications made to this crossing (modifications include pipe replacement, material used for pipe replacement, and debris left from construction on levees). (O. Magana - DWR UCIP)12/04/2013
Pipe rusted through on WS berm. Siphon breaker in CMP riser blocked by riser misalignment. (W. Wylie - DWR UCIP)
FIELD_STRUCT_DESC: *REMOVED* 12-inch steel drainpipe through the levee, 4 feet below the crown. Pump on pile structure in drainage ditch is located on the landside (LS). One corrugated metal cutoff wall and a siphon breaker in a 24-inch corrugated metal pipe (CMP) riser located on the waterside (WS) shoulder. Flap gate is located on the WS end. (12-inch pipe removed in 2016 no permit found authorizing work; 12-inch pipe authorized under Automatic Board Order (ABO) issued as Permit No. 10183, 1974 - Miller) [Additional Reference(s): DWR Levee Log, 2006. USACE Sacramento O&M Manual Unit 108, April 1964, As-built drawing no. 50-04-3379 (HLM 4.32)].

Pump on pier off LS toe at ponding area. power pole and meter on LS toe.

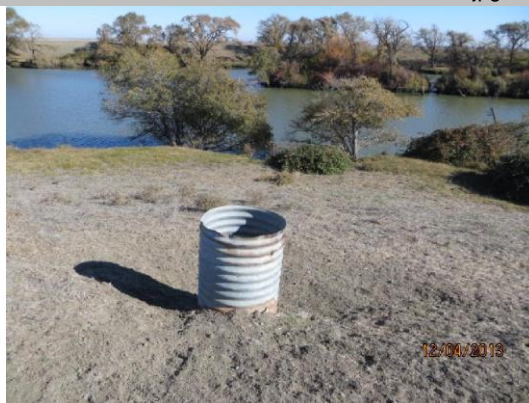
Photo 2 of 3 : UCIP_SP_2017_51640_45055.jpg

Siphon breaker in CMP riser on WS slope.

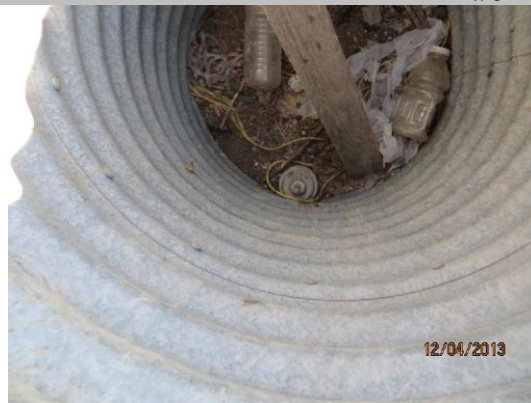
Photo 3 of 3 : UCIP_SP_2017_51640_45054.jpg

Comment Code					
Inspector Comment					
FS_ID:51640 DS_ID:24706 EP_NO: 10183 Repair Type: Urgent Crossing Status: Found UCIP Comments: 12/06/2016 Pipe has been replaced with PVC pipe. The crossing is non-functional due to pipe not attached to new pump. Need to contact owner. Owner will need to coordinate with CVFPB regarding the modifications made to this crossing (modifications include pipe replacement, material used for pipe replacement, and debris left from construction on levees). (O. Magana - DWR UCIP)12/04/2013 Pipe rusted through on WS berm. Siphon breaker in CMP riser blocked by riser misalignment. (W. Wylie - DWR UCIP) FIELD_STRUCT_DESC: *REMOVED* 12-inch steel drainpipe through the levee, 4 feet below the crown. Pump on pile structure in drainage ditch is located on the landside (LS). One corrugated metal cutoff wall and a siphon breaker in a 24-inch corrugated metal pipe (CMP) riser located on the waterside (WS) shoulder. Flap gate is located on the WS end. (12-inch pipe removed in 2016 no permit found authorizing work; 12-inch pipe authorized under Automatic Board Order (ABO) issued as Permit No. 10183, 1974 - Miller) [Additional Reference(s): DWR Levee Log, 2006. USACE Sacramento O&M Manual Unit 108, April 1964, As-built drawing no. 50-04-3379 (HLM 4.32)]. FS Date: 12/6/2016

Siphon breaker in CMP riser blocked by the risers misalignment.

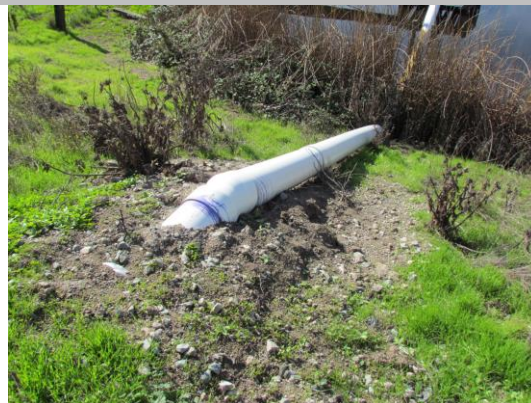
Photo 1 of 2 : SP_2017_RD2104_249_120_20170404_00007.jpg

LM Start	4.01	Rating **	U	Issue No.	120
LM End	4.01	Issue Type +	En	Location *	LS
Category	Earthen Levee			GPS Latitude/Longitude	
				Start	End
Item	Encroachments			38.310912 °	38.310912 °
				-121.736172 °	-121.736172 °
DWR ID	DWR_RD2104_01_f_2014_120				
Comment Code					
PI : Pipe					
Inspector Comment					
This pipe was written up during the inspection 2014. Unauthorized repairs, unacceptable plastic pipe and repairs done without CVFPB Permit.

View of unauthorized pipe through levee crown roadway leading to the pump in raised wooden structure in irrigation ditch landward.

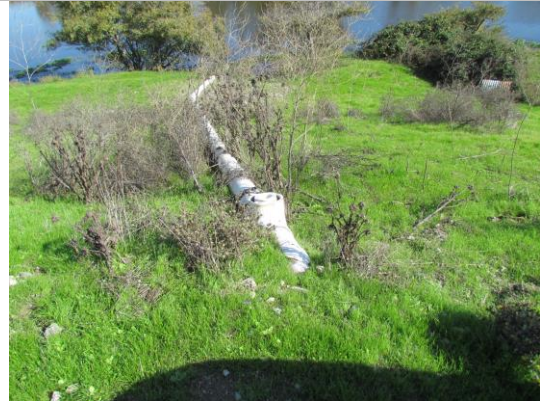
Photo 2 of 2 : SP_2017_RD2104_249_120_20170404_00008.jpg

LM Start	4.01	Rating **	U	Issue No.	120 (cont)
LM End	4.01	Issue Type +	En	Location *	LS
Category	Earthen Levee			GPS Latitude/Longitude	
				Start	End
Item	Encroachments			38.310912 °	38.310912 °
				-121.736172 °	-121.736172 °
DWR ID	DWR_RD2104_01_f_2014_120				
Comment Code					
PI : Pipe					
Inspector Comment					
This pipe was written up during the inspection 2014. Unauthorized repairs, unacceptable plastic pipe and repairs done without CVFPB Permit.

View of unauthorized pipe work, waterside slope. The siphon breaker broken off coupling.

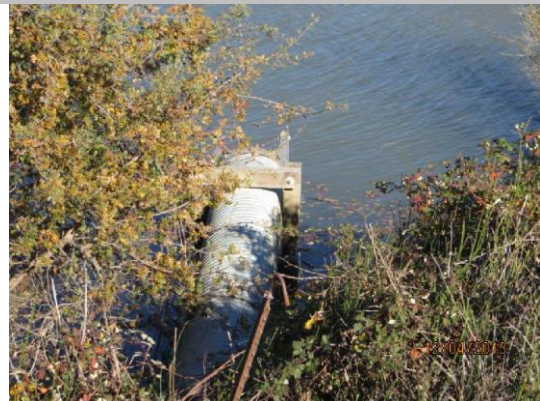
Photo 1 of 3 : UCIP_SP_2017_51459_45062.jpg

Comment Code					
Inspector Comment					
FS_ID:51459 DS_ID:24705 EP_NO: 10182 Repair Type: Non-Urgent Crossing Status: Found UCIP Comments: 12/06/2016 Crossing has been downgraded from "Urgent" to "Non-Urgent" no signs of leaks observed along pipe alignment (limited inspection on WS toe). According to LMA representative, this crossing was replaced 6 years ago (2010) at WS concrete apron. Recommend conducting internal inspection of pipe through the levee and LS to determine pipe integrity. (O. Magana - DWR UCIP)12/04/2013 Vegetation and soil buildup throughout pipe preventing flapgate from closing. Remove vegetation to allow gate to close properly. (W. Wylie - DWR UCIP) FIELD_STRUCT_DESC: 24-inch corrugated metal drainage pipe through the levee, 15 feet below the crown. 36-inch concrete standpipe located on the landside (LS) toe. Flapgate located on the waterside (WS) toe. Two corrugated metal (CM) cut of walls installed. (24-inch pipe authorized [HLM 4.65] under Automatic Board Order (ABO) issued as Permit No. 10182, 1974 - Machado) [Additional Reference(s): DWR Levee Log, 2006. USACE Sacramento O&M Manual Unit 108, April 1964, Asbuilt Dwg. 50-04-3379 (HLM 4.65)]. FS Date: 12/6/2016

CMP pipe and flapgate off WS toe.

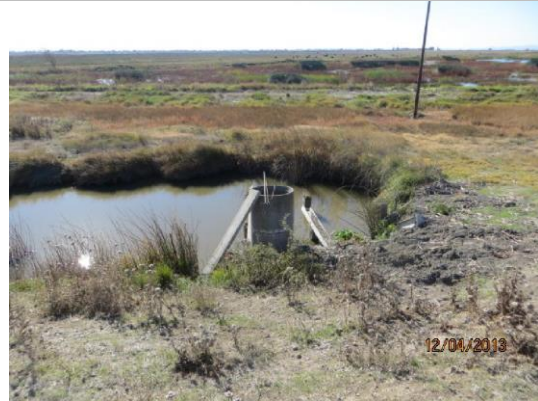
Photo 2 of 3 : UCIP_SP_2017_51459_45061.jpg

FS_ID:51459
DS_ID:24705
EP_NO: 10182
Repair Type: Non-Urgent
Crossing Status: Found
UCIP Comments: 12/06/2016 Crossing has been downgraded from "Urgent" to "Non-Urgent" no signs of leaks observed along pipe alignment (limited inspection on WS toe). According to LMA representative, this crossing was replaced 6 years ago (2010) at WS concrete apron. Recommend conducting internal inspection of pipe through the levee and LS to determine pipe integrity. (O. Magana - DWR UCIP)12/04/2013 Vegetation and soil buildup throughout pipe preventing flapgate from closing. Remove vegetation to allow gate to close properly. (W. Wylie - DWR UCIP)
FIELD_STRUCT_DESC: 24-inch corrugated metal drainage pipe through the levee, 15 feet below the crown. 36-inch concrete standpipe located on the landside (LS) toe. Flapgate located on the waterside (WS) toe. Two corrugated metal (CM) cut of walls installed. (24-inch pipe authorized [HLM 4.65] under Automatic Board Order (ABO) issued as Permit No. 10182, 1974 - Machado) [Additional Reference(s): DWR Levee Log, 2006. USACE Sacramento O&M Manual Unit 108, April 1964, Asbuilt Dwg. 50-04-3379 (HLM 4.65)].

36-inch concrete riser on LS toe at channel.

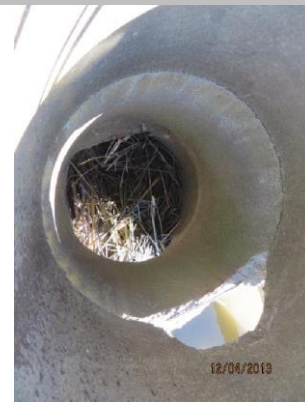
Photo 3 of 3 : UCIP_SP_2017_51459_45060.jpg

36-inch concrete riser with vegetation buildup inside.

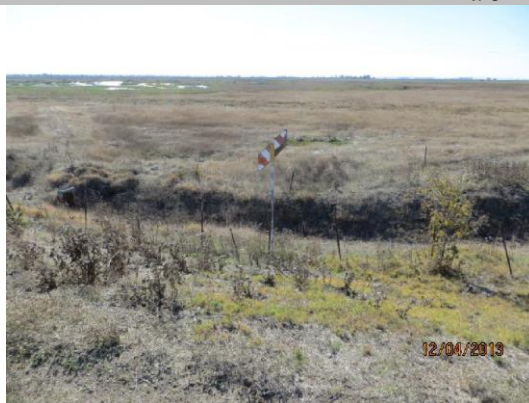
Photo 1 of 2 : UCIP_SP_2017_25003_45081.jpg

LM Start	4.65	Rating **	M	Issue No.	126
LM End	4.65	Issue Type +	En	Location *	LS
Category	Supplemental			GPS Latitude/Longitude	
				Start	End
Item	DWR UCIP Field Study			38.317941 °	38.317941 °
				-121.743503 °	-121.743503 °
DWR ID					
Comment Code					
Inspector Comment					
FS_ID:25003 DS_ID:24704 EP_NO: 10182 Repair Type: Non-Urgent Crossing Status: Found UCIP Comments: Sign on WS toe needs repair. FIELD_STRUCT_DESC: 8-inch gas line through levee at high elevation. Sign on WS and LS toe. (ABO No. 10182 - Machado) Asbuilt Dwg. 50-04-3379. FS Date: 12/4/2013

Gasline marker on LS toe.

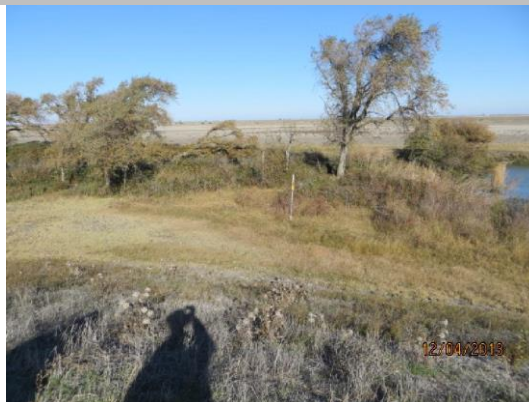
Photo 2 of 2 : UCIP_SP_2017_25003_45080.jpg

Sign pole on WS toe missing sign.

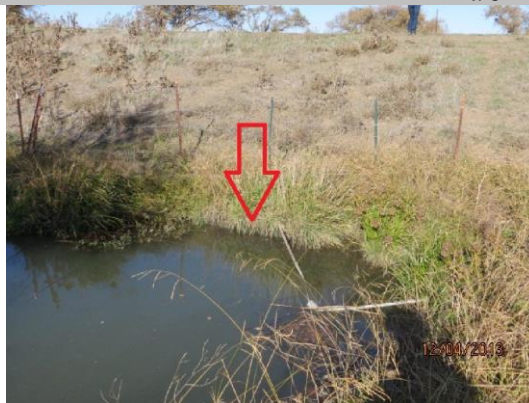
Photo 1 of 2 : UCIP_SP_2017_25005_45083.jpg

LM Start	4.67	Rating **	M	Issue No.	127
LM End	4.67	Issue Type +	En	Location *	LS
Category	Supplemental			GPS Latitude/Longitude	
				Start	End
Item	DWR UCIP Field Study			38.318119 °	38.318119 °
				-121.743730 °	-121.743730 °
DWR ID					
Comment Code					
Inspector Comment					
FS_ID:25005					
DS_ID:24703					
EP_NO: N/A					
Repair Type: Non-Urgent					
Crossing Status: Found					
UCIP Comments: Good candidate for video inspection.					
FIELD_STRUCT_DESC: 18-inch steel irrigation pipe through the levee					
13.5-feet below the crown. Pump on pile structure in stream. Slide gate					
in 36-inch CMP riser on waterward slope. Two cutoff walls. Concrete					
"U" headwall and air vent at toe of landward slope. Asbuilt Dwg. 50-04-					
3379. Electrical conduit through levee at same location.					
FS Date: 12/4/2013

Concrete headwall on LS toe at irrigation ditch.

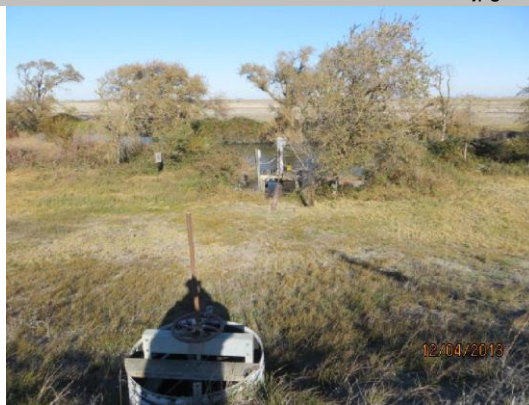
Photo 2 of 2 : UCIP_SP_2017_25005_45082.jpg

Slide gate in CMP riser on WS slope with pump on pier in background.

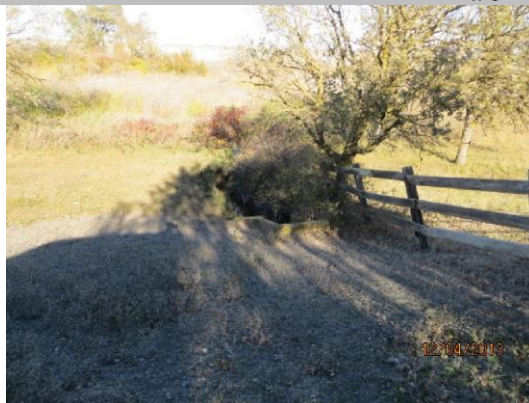
Photo 1 of 3 : UCIP_SP_2017_25006_45086.jpg

LM Start	4.72	Rating **	M	Issue No.	128
LM End	4.72	Issue Type +	En	Location *	LS
Category	Supplemental			GPS Latitude/Longitude	
				Start	End
Item	DWR UCIP Field Study			38.318432 °	38.318432 °
				-121.744540 °	-121.744540 °
DWR ID					
Comment Code					
Inspector Comment					
FS_ID:25006					
DS_ID:24702					
EP_NO: 10182					
Repair Type: Non-Urgent					
Crossing Status: Found					
UCIP Comments: Minor erosion of base under headwall on WS toe.					
Heavy corrosion of pipe at WS toe. Further evaluation of pipe integrity needed.					
FIELD_STRUCT_DESC: 24-inch CMP drain pipe through the levee					
13.5-feet below the crown. Concrete "U" headwalls on both ends. Two					
C.M. cutoff walls. Flap gate on waterward end. (ABO No. 10182 -					
Machado)					
FS Date: 12/4/2013

Concrete U shaped headwall on WS toe.

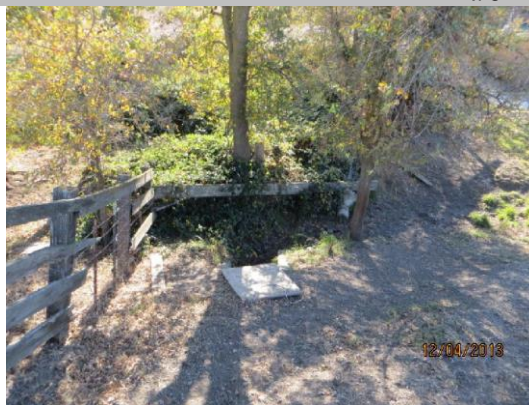
Photo 2 of 3 : UCIP_SP_2017_25006_45085.jpg

Concrete U shaped headwall on LS toe.

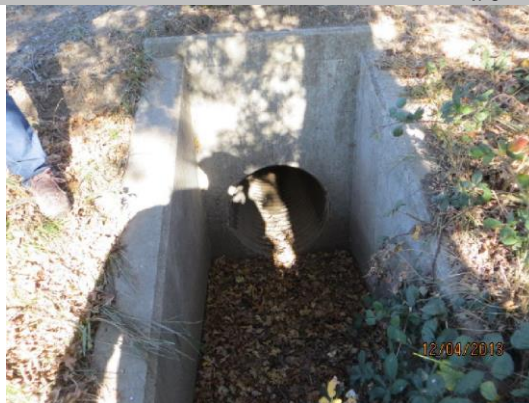
Photo 3 of 3 : UCIP_SP_2017_25006_45084.jpg

LM Start	4.72	Rating **	M	Issue No.	128 (cont)	
LM End	4.72	Issue Type +	En	Location *	LS	
Category	Supplemental			GPS Latitude/Longitude		
				Start		End
Item	DWR UCIP Field Study			38.318432 °		38.318432 °
				-121.744540 °		-121.744540 °
DWR ID						
Comment Code						
Inspector Comment						
FS_ID:25006						
DS_ID:24702						
EP_NO: 10182						
Repair Type: Non-Urgent						
Crossing Status: Found						
UCIP Comments: Minor erosion of base under headwall on WS toe.						
Heavy corrosion of pipe at WS toe. Further evaluation of pipe integrity						
needed.						
FIELD_STRUCT_DESC: 24-inch CMP drain pipe through the levee						
13.5-feet below the crown. Concrete "U" headwalls on both ends. Two						
C.M. cutoff walls. Flap gate on waterward end. (ABO No. 10182 -						
Machado)						
FS Date: 12/4/2013

Concrete U shaped headwall on LS toe.

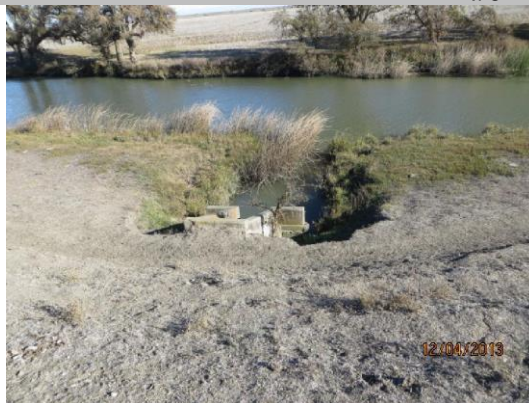
Photo 1 of 3 : UCIP_SP_2017_51460_45090.jpg

Comment Code					
Inspector Comment					
FS_ID:51460 DS_ID:24701 EP_NO: 10182 Repair Type: Urgent Crossing Status: Found UCIP Comments: 12/06/2016 same as last inspection--pipe remains "Urgent" CMP shows holes through wall and concrete headwall is undermined. Need to contact owner. Owner will need to work with the CVFPB to comply with Title 23. (O. Magana - DWR UCIP)12/04/2013 Footing under headwall on WS toe severely undermined. Pipe rusted heavily with holes at WS and may need replacement. (W. Wylie - DWR UCIP) FIELD_STRUCT_DESC: 24-inch corrugated metal drainage pipe (permit recordation list 24-inch pipe and USACE O&M manual references a 18-inch pipe) through levee, 13 feet below crown. Two cutoff walls. Concrete "U" headwalls located on both waterside (WS) and landside (LS) ends. Flap gate located on the WS. (24-inch pipe authorized under Automatic Board Order (ABO) issued as Permit No. 10182 - Machado). [Additional Reference(s): DWR Levee Log, 2006. USACE Sacramento O&M Manual Unit 108, April 1964, As-built drawing no. 50-04-3379 (HLM 5.06)]. FS Date: 12/6/2016

Concrete U-shaped headwall on WS toe. Note erosion scarp around headwall.

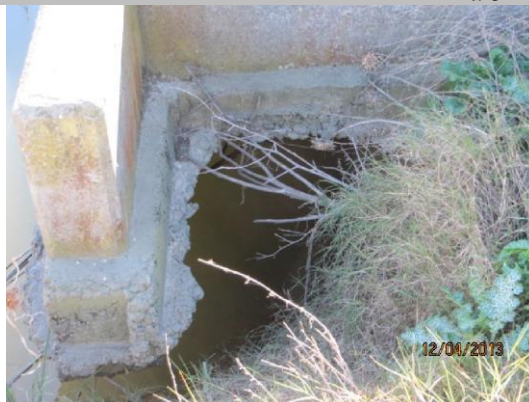
Photo 2 of 3 : UCIP_SP_2017_51460_45089.jpg

Headwall undermined on WS toe.

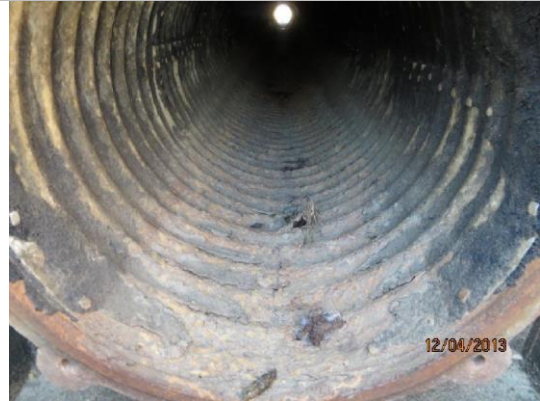
Photo 3 of 3 : UCIP_SP_2017_51460_45088.jpg

Corrosion through pipe with holes on WS toe.

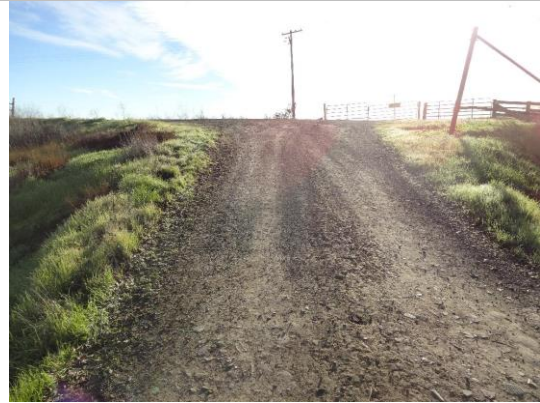
Photo 1 of 3 : UCIP_SP_2017_51461_76913.jpg

Comment Code					
Inspector Comment					
FS_ID:51461 DS_ID:24699 EP_NO: 10184 Repair Type: Urgent Crossing Status: Indicator Found UCIP Comments: 12/06/2016 No indicators were found. According to LMA representative, the gas line has been abandoned and markers have been removed about 10-15 years ago. Solano County was performing work on the LS toe approximately 700 feet from LS toe and according to their underground service alert (USA) survey completed for their construction site no PGE line was identified. Need to contact owner to determine abandoned as-builts for 8-inch line. (O. Magana - DWR UCIP)12/04/2013 Pump station visible to north on LS toe. Good indicator of location. Need PG+E to mark pipe location. (W. Wylie - DWR UCIP) FIELD_STRUCT_DESC: 8-inch iron gas line through levee, 2 feet below crown. (8-inch gas line authorized under Automatic Board Order (ABO) issued as Permit No. 10184, 1975 - Pacific Gas and Electric Co. [PG&E]; 8-inch gas line first referenced in the USACE O&M as-builts from 1956). [Additional Reference(s): DWR Levee Log, 2006. USACE Sacramento O&M Manual Unit 108, April 1964, As-built drawing no. 50-04-3379A sheet 3379/2, page 2 of 7 (near STA 82+30, HLM 7.38)]. FS Date: 12/6/2016

No signs present at ramp to enter RD2104.

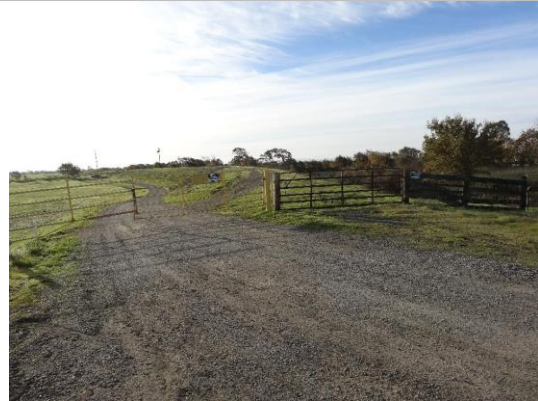
Photo 2 of 3 : UCIP_SP_2017_51461_76914.jpg

FS_ID:51461
DS_ID:24699
EP_NO: 10184
Repair Type: Urgent
Crossing Status: Indicator Found
UCIP Comments: 12/06/2016 No indicators were found. According to LMA representative, the gas line has been abandoned and markers have been removed about 10-15 years ago. Solano County was performing work on the LS toe approximately 700 feet from LS toe and according to their underground service alert (USA) survey completed for their construction site no PGE line was identified. Need to contact owner to determine abandoned as-builts for 8-inch line. (O. Magana - DWR UCIP)12/04/2013 Pump station visible to north on LS toe. Good indicator of location. Need PG+E to mark pipe location. (W. Wylie - DWR UCIP)
FIELD_STRUCT_DESC: 8-inch iron gas line through levee, 2 feet below crown. (8-inch gas line authorized under Automatic Board Order (ABO) issued as Permit No. 10184, 1975 - Pacific Gas and Electric Co. [PG&E]; 8-inch gas line first referenced in the USACE O&M as-builts from 1956). [Additional Reference(s): DWR Levee Log, 2006. USACE Sacramento O&M Manual Unit 108, April 1964, As-built drawing no. 50-04-3379A sheet 3379/2, page 2 of 7 (near STA 82+30, HLM 7.38)].

No signs present of gas line.

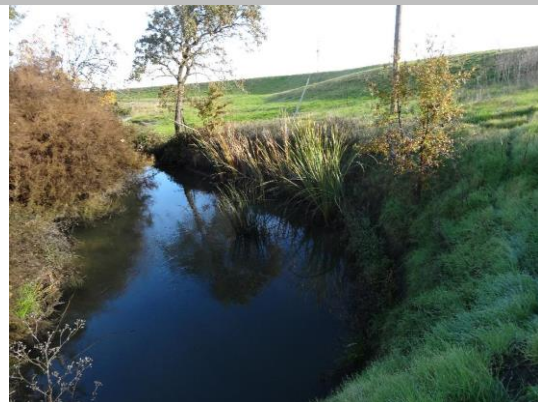
Photo 3 of 3 : UCIP_SP_2017_51461_76915.jpg

Photo of where the line is estimated to cross on LS.
